# The Specialist – “sharing through experience”

## Developments in Low Pressure Storage Tanks

## Tank failure due to blocked vent leads to costly repair and impact on production

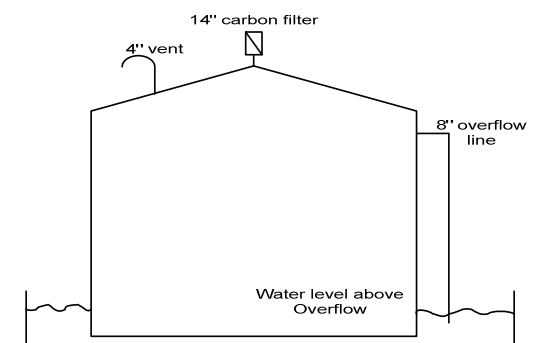
- Prolonged rain filled the bund to a level above the overflow pipe exit.
- Later, the pressure in the storage tank fell either due to thermal cooling or liquid transfer out (or both).
- The inbreathing capacity of the vents was insufficient and the roof was sucked in.
- The incident had not occurred before because the storage tank inbreathed through the overflow line.
- The carbon filter vent was blocked – it hadn't been inspected or maintained for at least 5 years
- The water level in the bund stopped the overflow from acting as a vent; the 4” vent had insufficient inbreathing capacity.

1. In this incident the tank failed at the roof. More commonly tanks tend to fail at shell and floor to shell weld with increased likelihood of a significant loss of containment. In this case the bund also had a level of water!!
2. The vent / relief case on storage tanks must be thoroughly understood and documented and measures put in place to prevent potential failures occurring.
3. This incident highlights the danger of ignoring the maintenance of fine element equipment in vent lines and bund house keeping.
