Pressure Vessel Failure during Hydrotest-Nov. 2007 in China

January 9, 2008

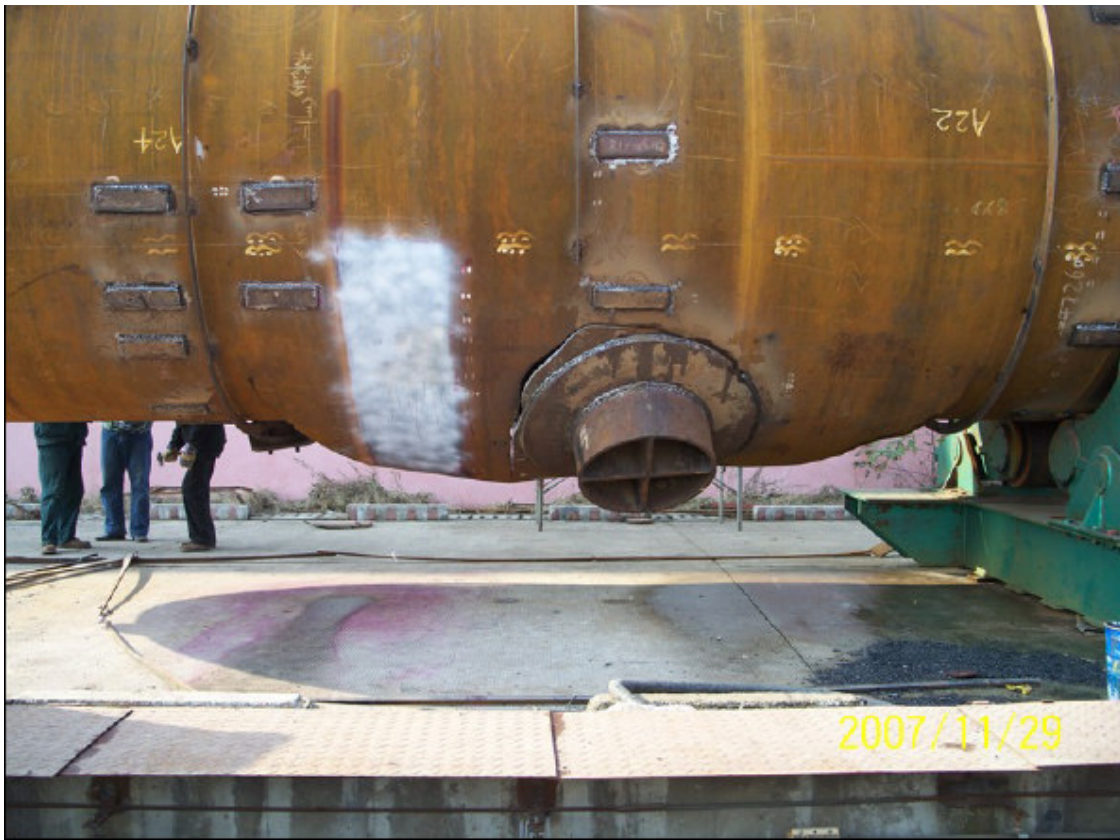
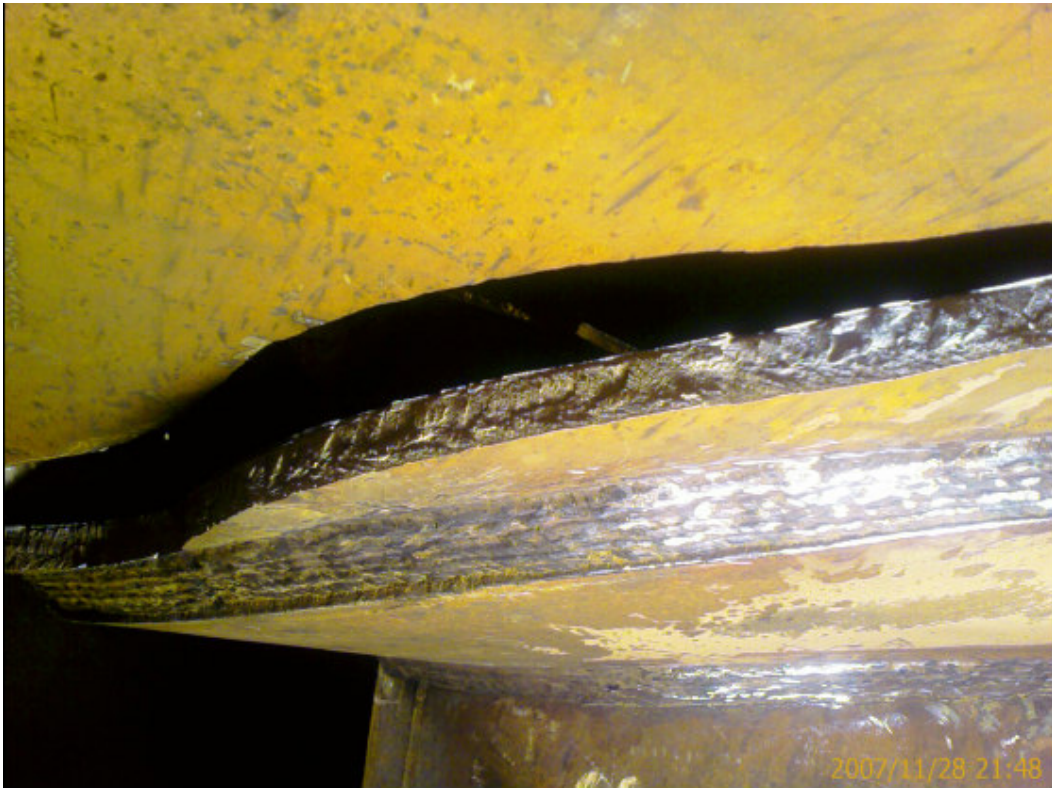
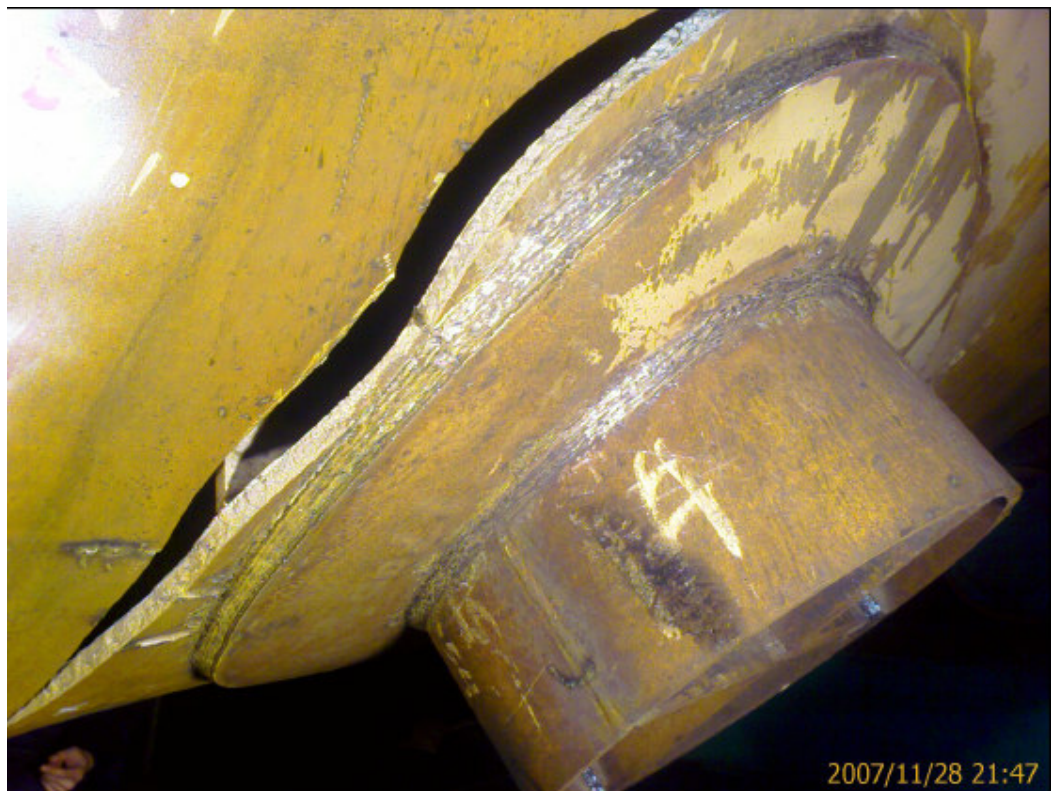
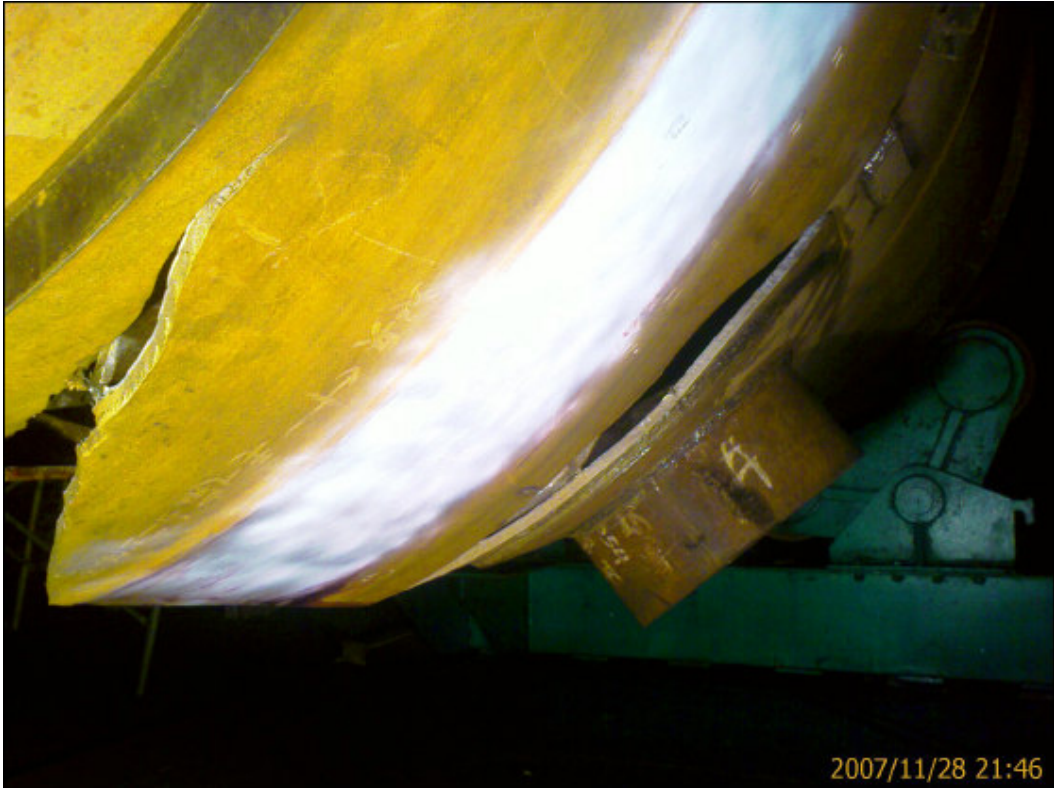
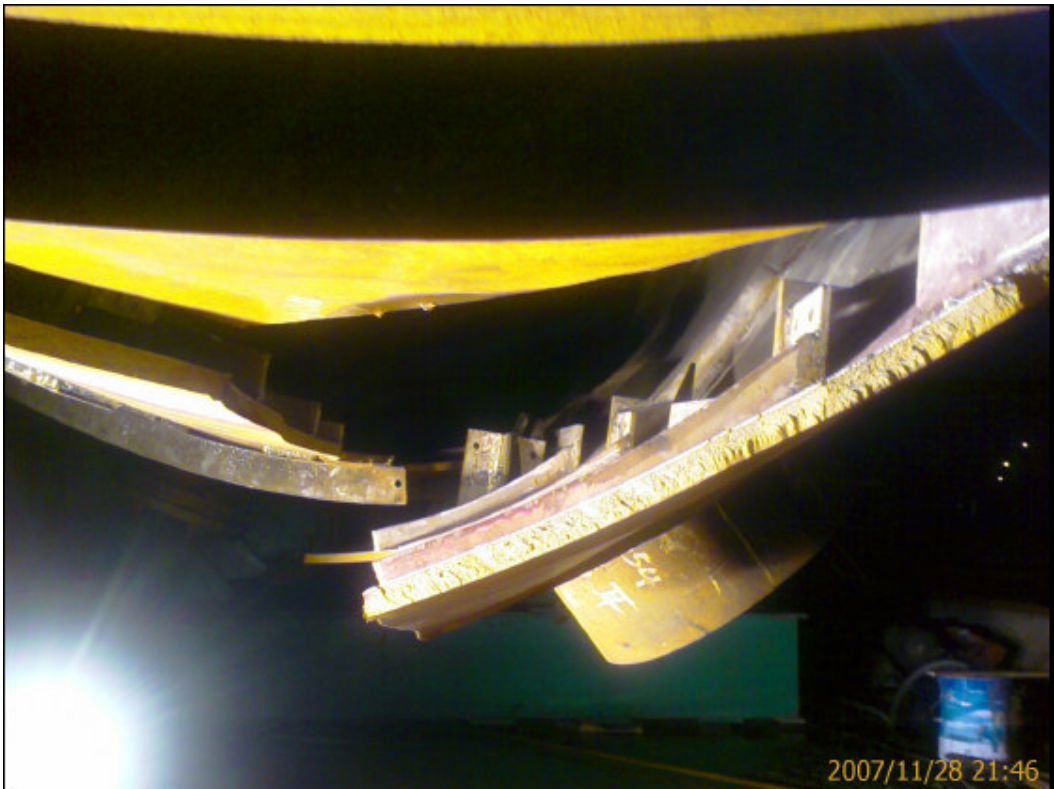
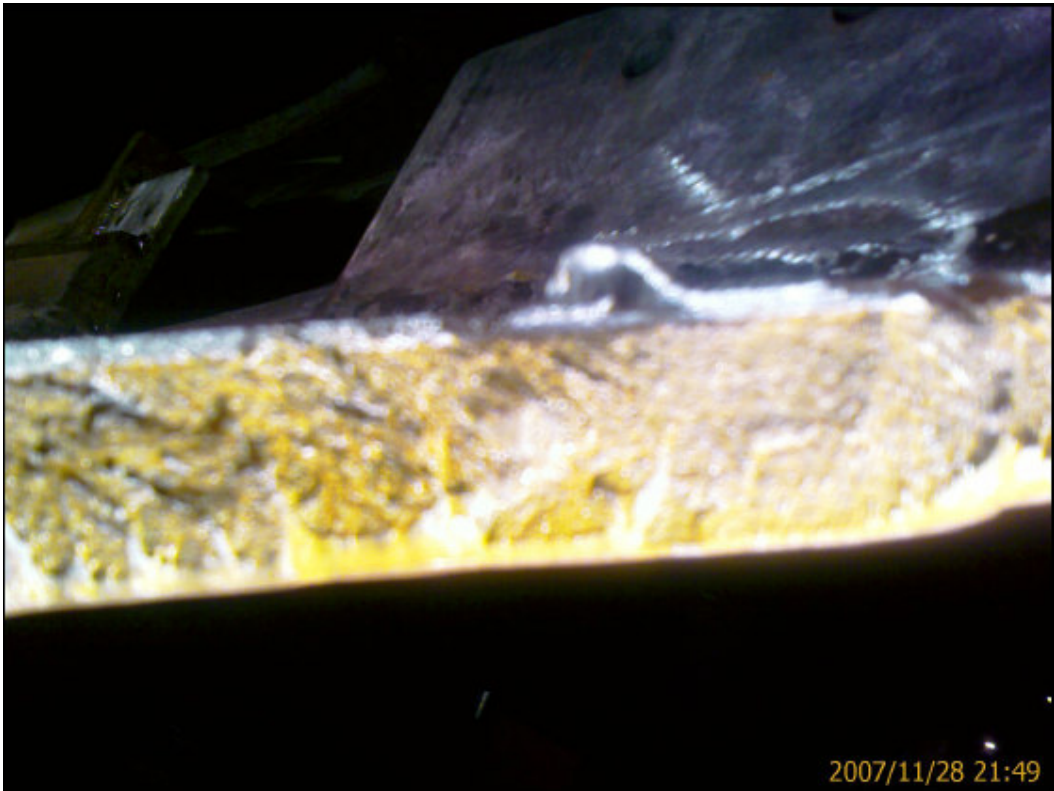
Please find attached photos of a pressure vessel that recently failed whilst under hydrotest during post fabrication testing. This vessel was manufactured by a vessel vendor in China and the plate was of Chinese mill origin. Unfortunately this is another example of serious equipment/material failures with equipment being sourced out of the rapidly developing economies such as China, Eastern Bloc and others. These examples are becoming almost a weekly occurrence now and are exhibiting failure modes not seen in the mature manufacturing economies since the 1930's. Again we need to ensure vigilance in the acceptance of manufacturers and once more I stress the need to know where the base materials are sourced from.

Apparently this pressure vessel had reached fifty percent of the required test pressure when the shell ruptured. A metallurgical failure report is not available however from the photographs a number of observations could be made regarding the quality of the material and the welding.

- (1) All base metal requirements shall be specified in P.O Requisition per project/Industry Code requirements.
- (2) Consult specialists (i.e., Materials and Corrosion Engineers) whenever you doubt.
- (3) All inspection (from base materials to final products) should be performed per the codes, specs & standards.
- (4) Especially when you selected the manufacturers in China, the above (1), (2) & (3) will be a very important message.
